EXPERTISE REPORT

December 2013

# Sazani island (Albania) : pollution and wastes field survey

Jean-Louis Lambeaux (13 Développement)

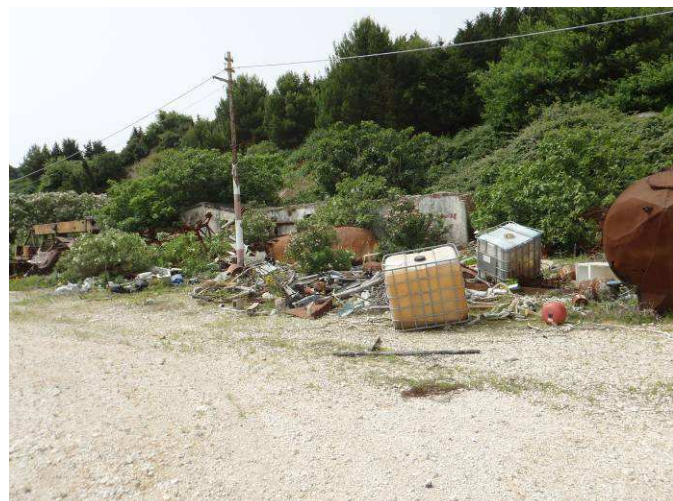
### Location 1 :

Close to the harbour, this place is a wasteland area. Soils are littered of pieces of metal as : a big tank (about 100 m3), a crane, a truck wreck,....

We estimate at 3 tons of easy metal to remove (except big tank), and about 1 ton of non-hazardous industrial waste (plastic, wood,...).

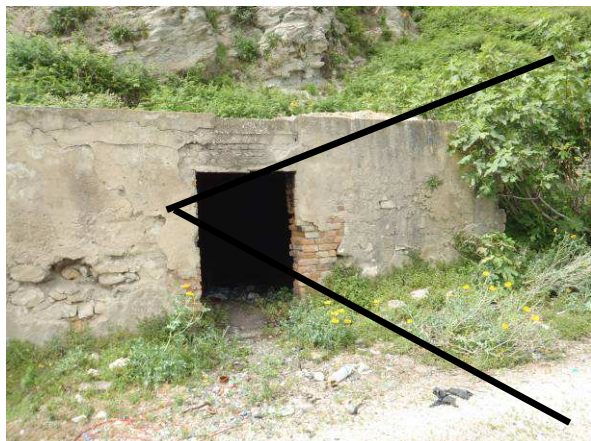
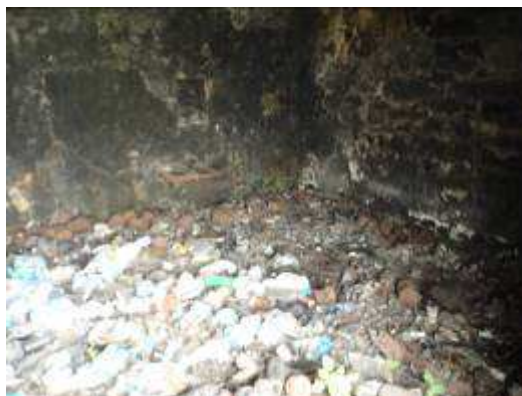
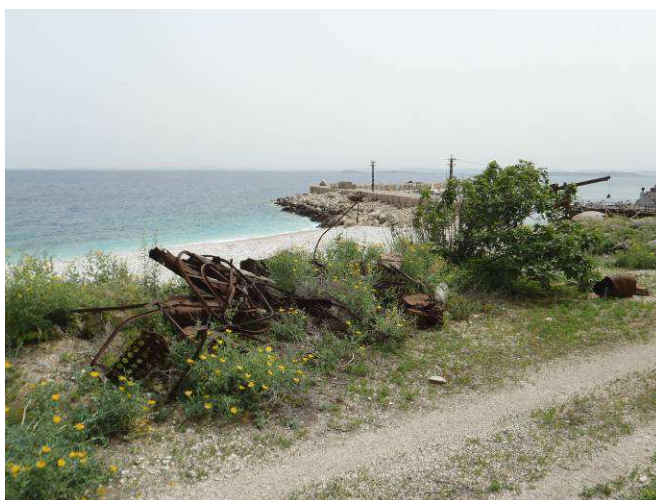
**Location 2 :**

A brick-built construction which is used nowadays to burn waste. Around this place, pieces of metal: about 3.5 tons  
Plastics litters: 0.1 ton

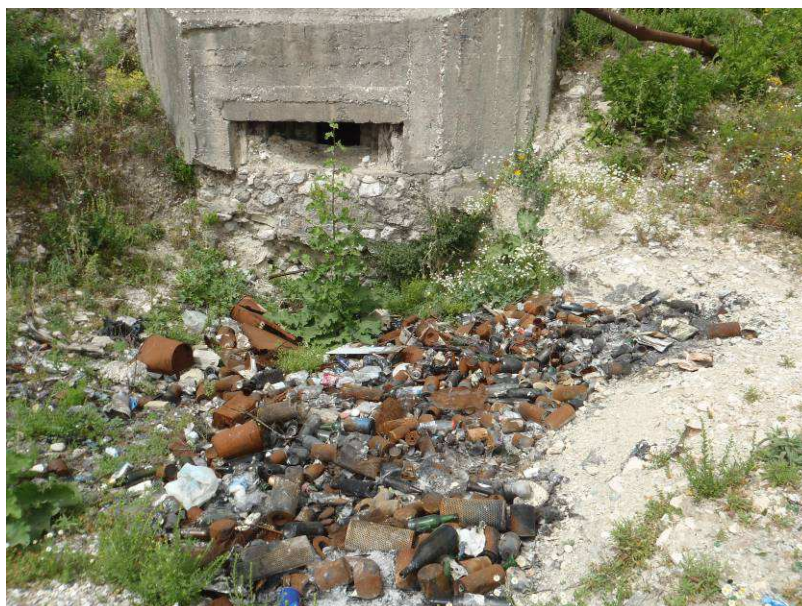
**Location 3 :**

In front of a bunker, another burning site, with about 0.1 tons of metal and glass.

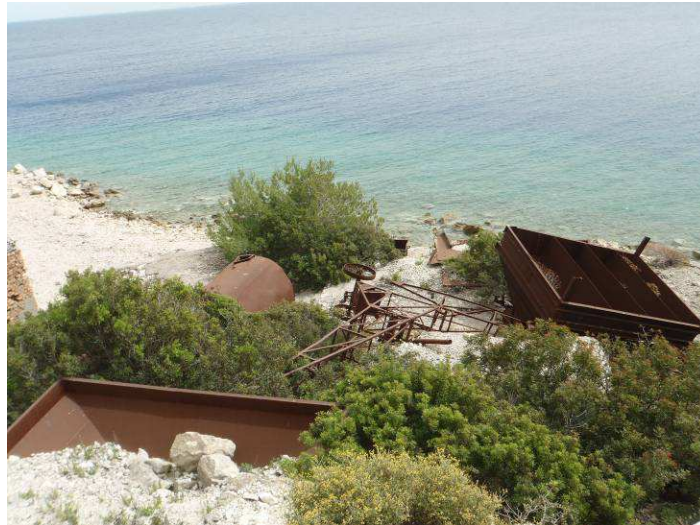
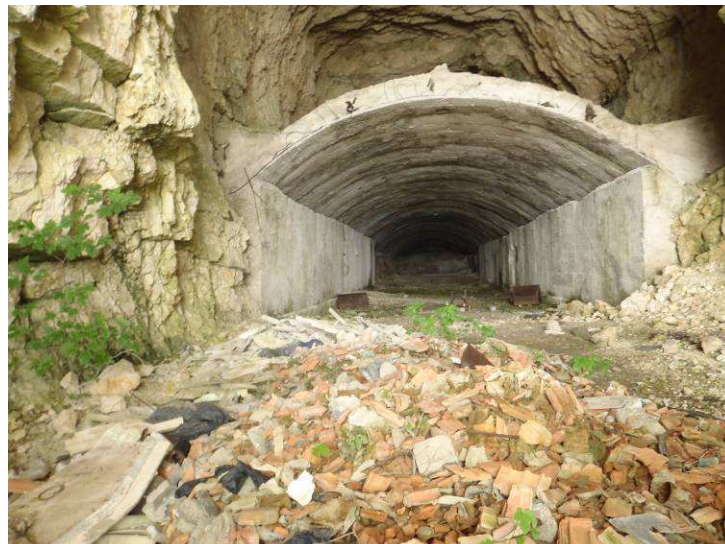
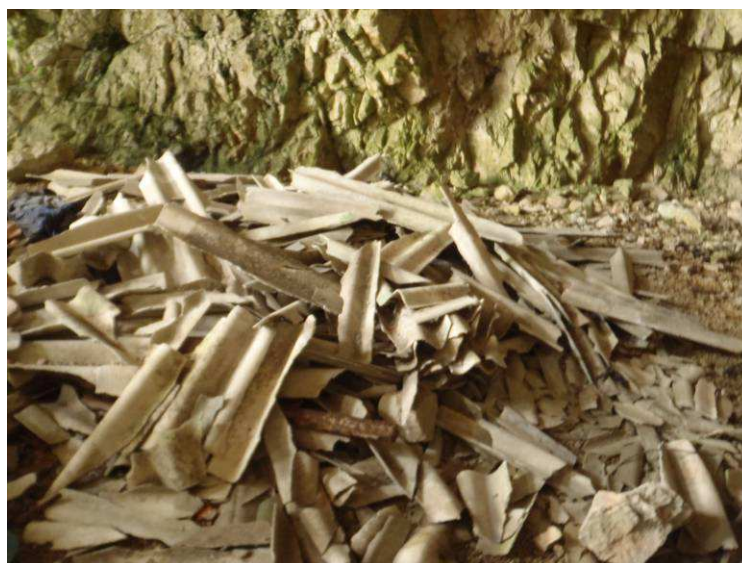
**Location 4 :**

3 larges natural limestone caves reinforced with concrete vault (about 100 m long, 15 m large, 8 m height). The vault of the first one (coming from the south), is partly collapsed and dangerous. In the middle-one, about 50 m2 of demolition waste, and 10 m2 of asbestos plate (vault is in good condition). The third one is half bathed. In front of and close to the bunkers, there are pieces of metal and 3 tanks, frame (4 tons).

One management possibility should be the containment of non-dangerous waste containment (wood, rubble...) inside a bunker in a good structural state (East zone - location 4), with reversibility possibility. Some works on the access pathway should be necessary.

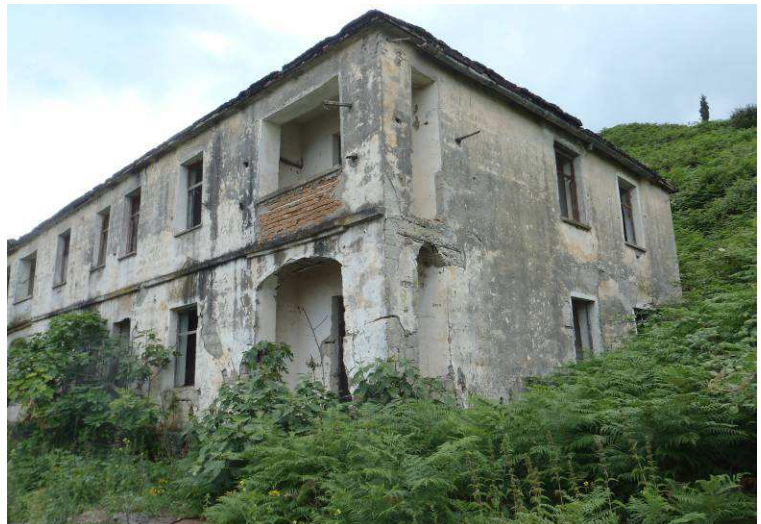
**Location 6:**

Large two-floors masonry and bricks construction with concrete flat roof.  
Average condition.  
Metal : 1 ton  
Garbage (Wood, plastic,...) : 0.2 tons

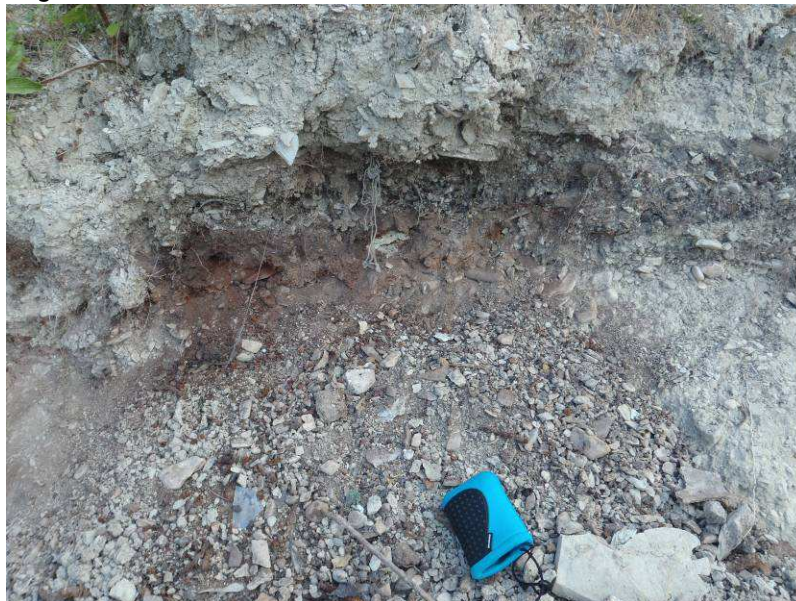
**Location 7:**

At the top of the small beach in the south of the quay. A thin soil polluted layer (0.2 m thick and about 15 m<sup>2</sup>), result of backfilling with burning wastes.

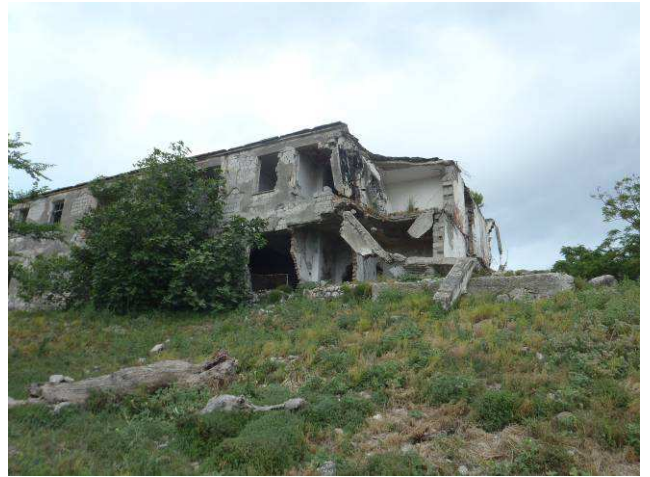
**Location 2:**

Housing : Two-floors masonry construction partly collapsed.  
Metal : 1.5 tons  
Garbage (wood, fabrics, mattress, plastic,...) : 0.2 tons

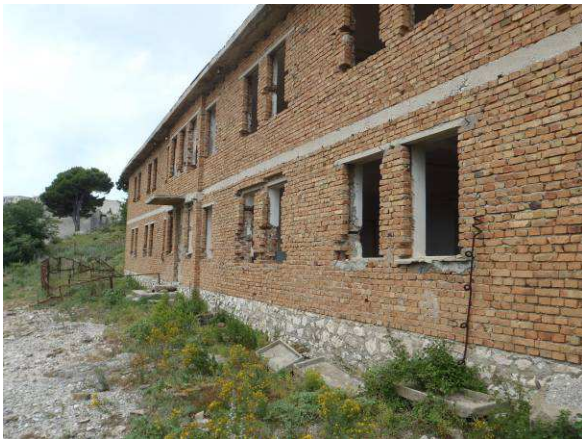
**Location 3:**

Housing : Two-floors masonry construction in average general condition (locally bad).  
Metal : 1 tons

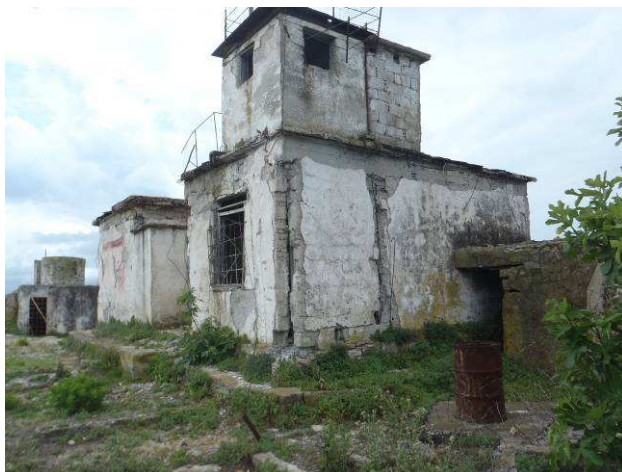
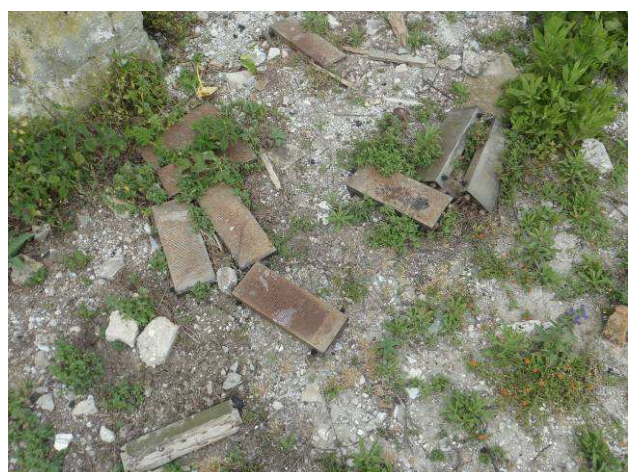
**Location 4:**

Small semaphore : Concrete and masonry construction in bad condition.  
Metal : 0,3 tons (empty barrels)  
Battery : 10 units  
Garbage : 0.1 ton

Dangerous wastes (batteries, asbestos, powder filled barrels ...) must be evacuated on the continent by a specialized company (with specific individual equipment).

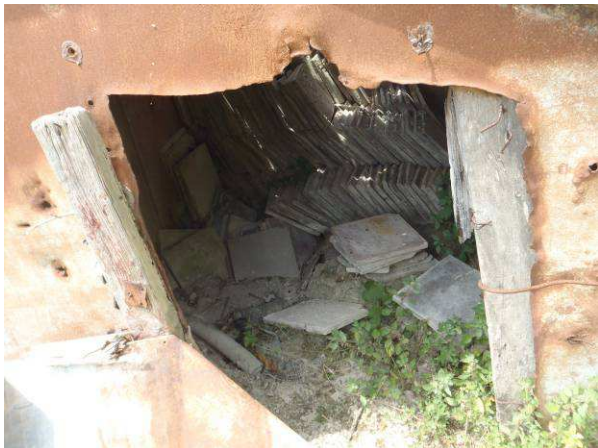
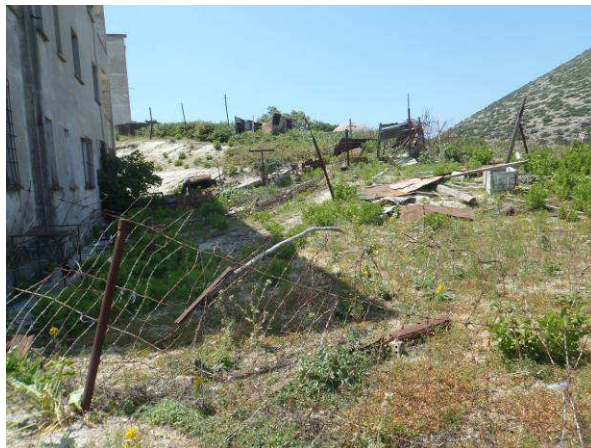
**Location 7 to 12:**

Housing : three-floors brick construction in average condition.  
Metal : 6.5 tons  
Small stock of cement stone floor  
Garbage : 1 ton

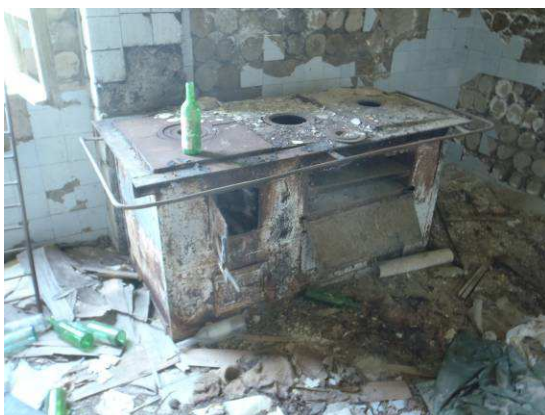
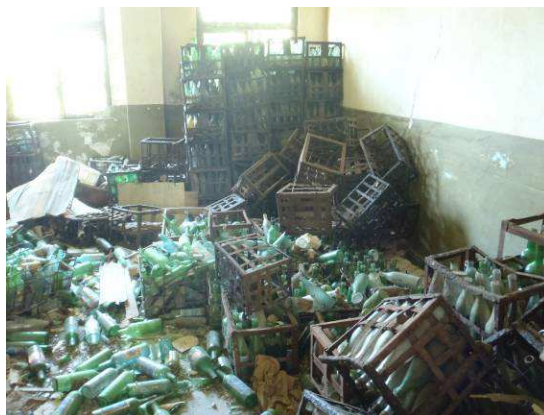
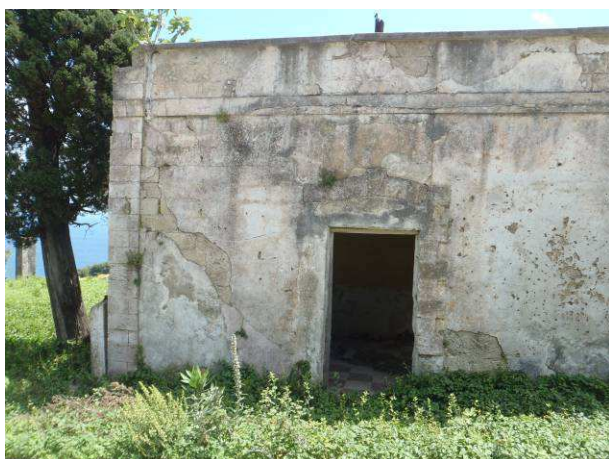
**Location 13:**

Dancing room: Masonry construction in average condition.

Metal : 1 ton

Garbage : 0.2 ton

Glass : 0.5 ton

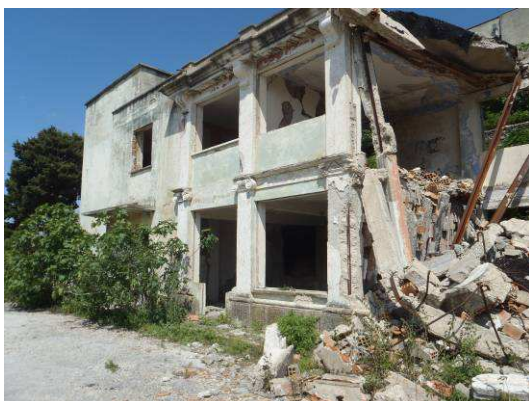
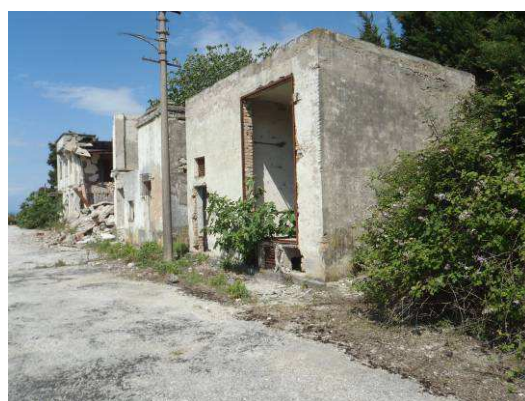
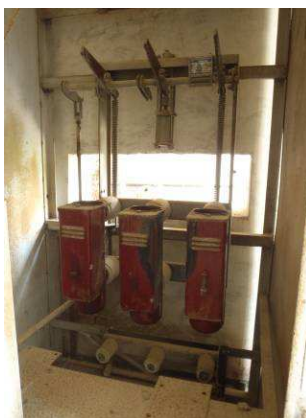
**Location 17:**

Two floors bricks and masonry construction in middling condition and partly collapsed, and small electric transformer station (electric cupboard without pyralene oil).

Metal : 0.6 tons

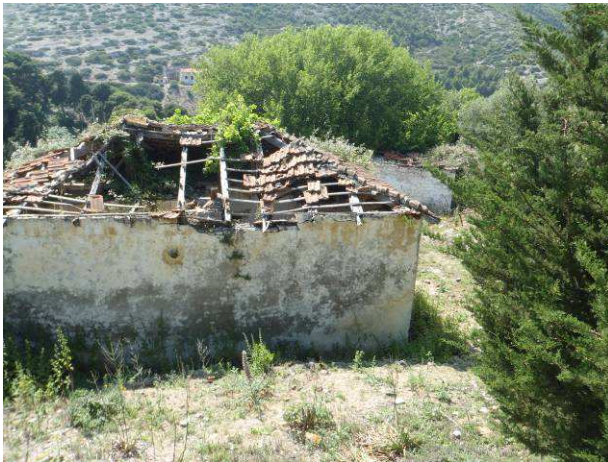
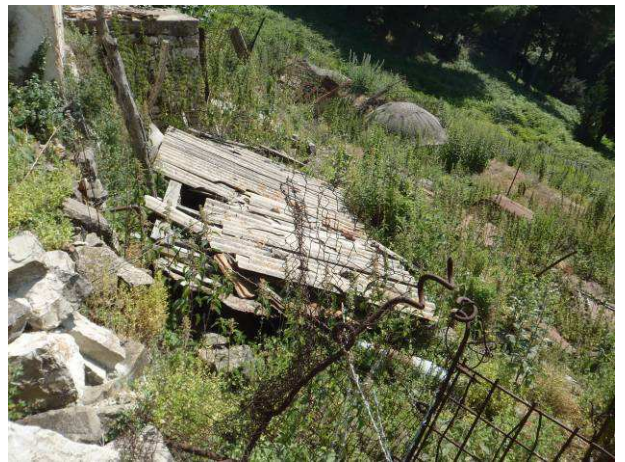
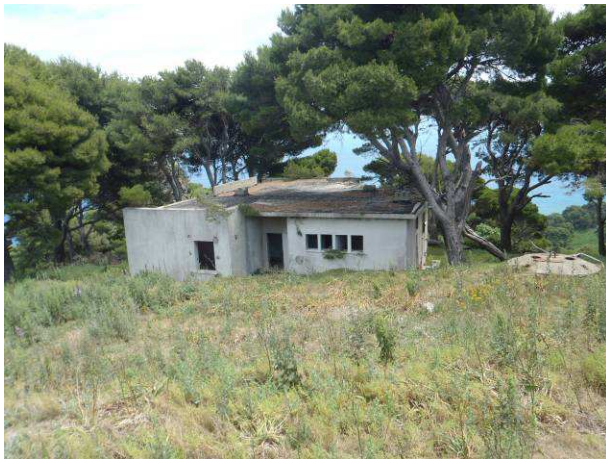
**Location 18:**

Eight small traditional houses in middling condition (3 of them in ruin) and locally bad (roof partly collapsed and).  
Metal : 0.6 tons  
20 m<sup>2</sup> of plate in asbestos.

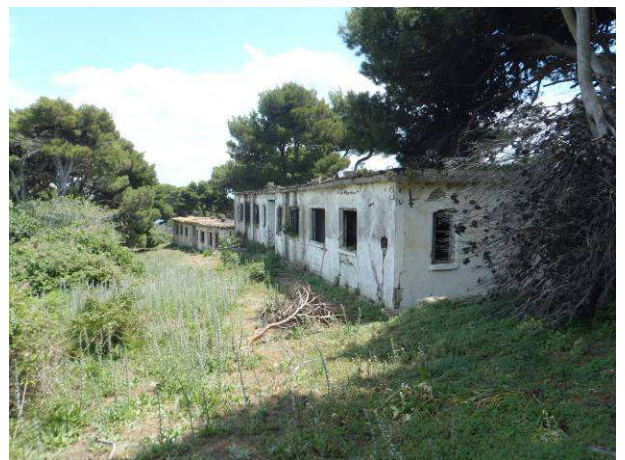
**Location 20:**

Group of four small ground-floor masonry constructions in middling condition and locally bad.  
Metal : 1 ton  
Garbage (wood) : 0.5 ton

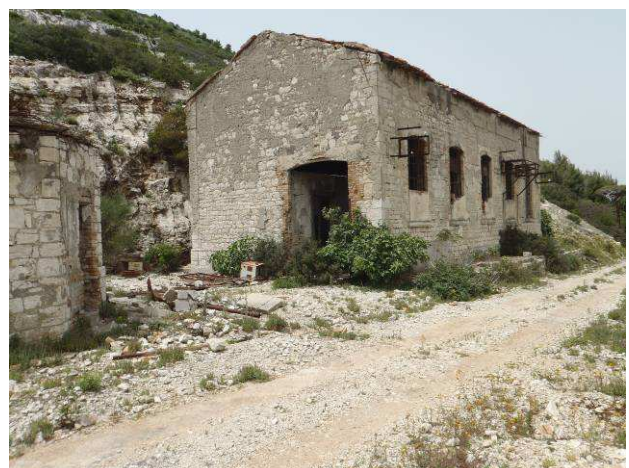
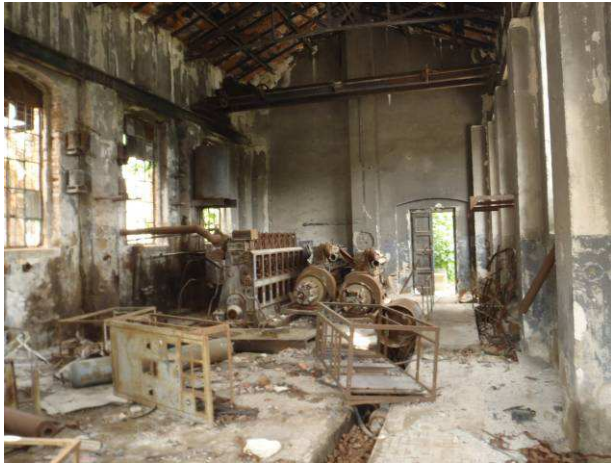
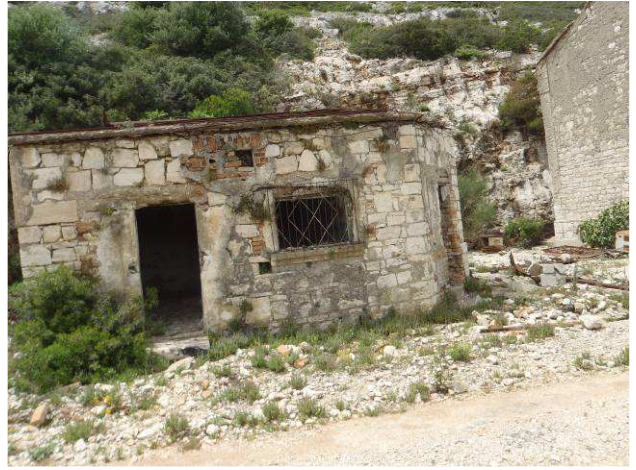
### Location 1:

Two limestone blocks constructions in good condition (unsteady concrete roof on the small construction). 3 generators sets and 2 metallic tanks.  
A bunker with 2 generators sets.

Metal : 3.5 tons (not counting generators to leave).  
Garbage (wood) : 0.5 ton

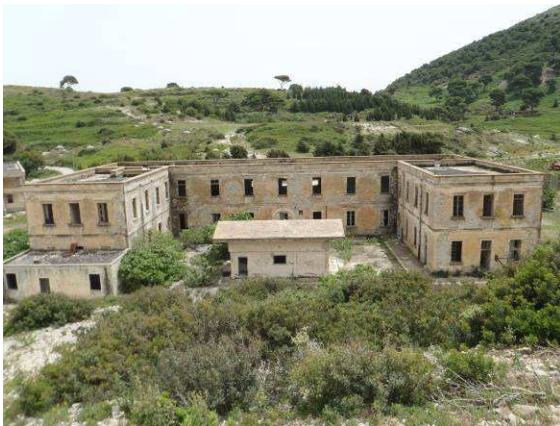
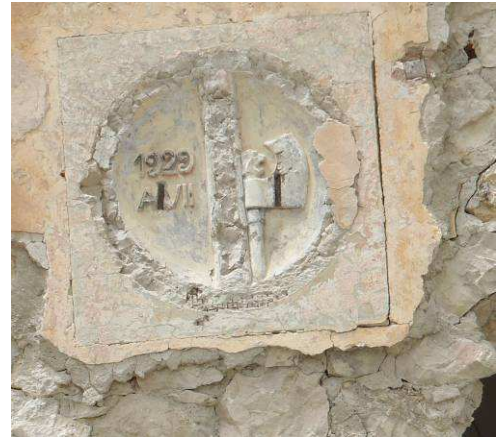
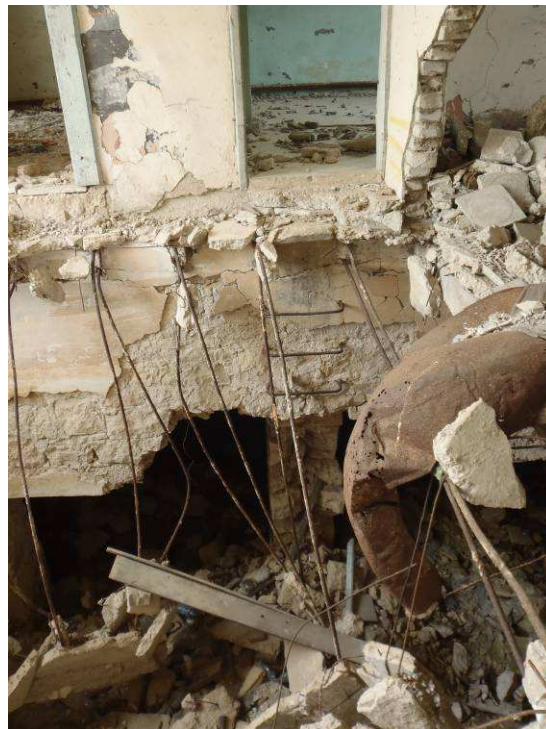
**Location 2:**

Hospital (1929). Two grounds limestone blocks constructions in quite good condition - basement inaccessible (locally collapsed parts). Concrete roof must be inspected in detail.

Metal : 3 tons (counting boiler).  
Battery : 30 units

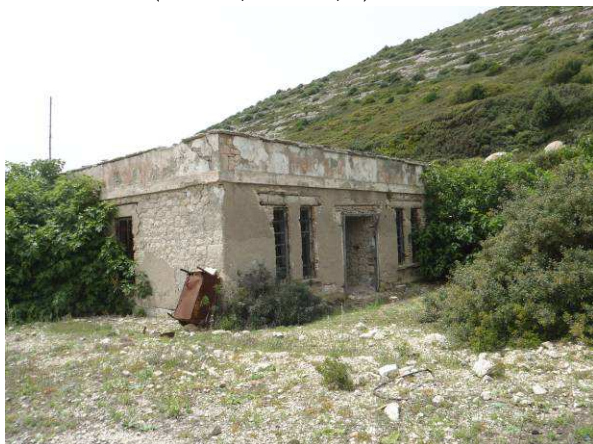
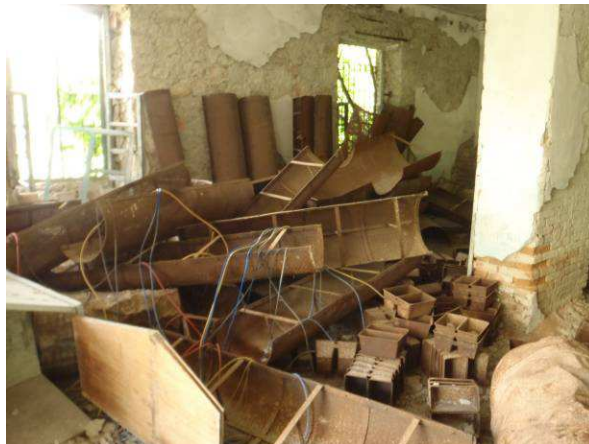
**Location 3:**

Bakery?. Ground floor limestone construction in middling condition.

Metal : 3.5 tons (screen?, crusher,...).

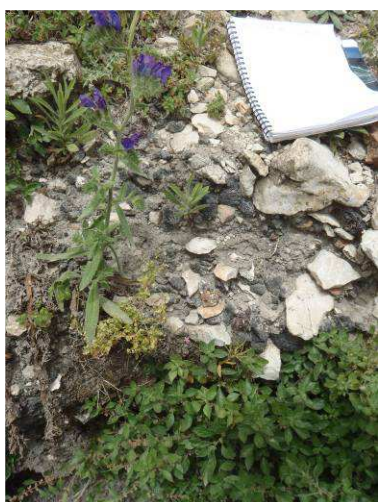
**Location 6:**

Ground floor bricks construction.

Metal : 0.4 ton (5 empty barrels, 8 beam balances)

Boxes with glass bottles: 0.3 ton

Near and in the south-est of this construction, a thin soil polluted layer, result of backfilling with burning wastes (0.3 m thick, area extension area undefined).

10 metallic elements (tanks, part of a truck,...) : 3 tons

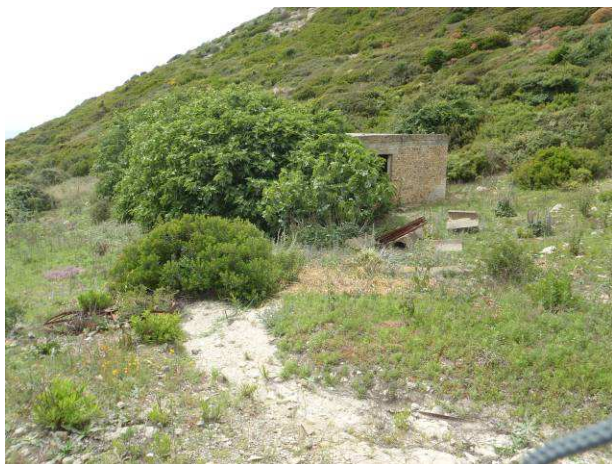
**Location 7:**  
Only foundations remains.  
Metal : few military helmets

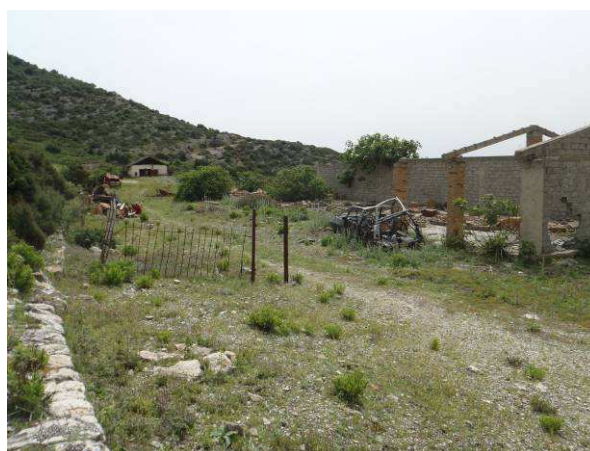
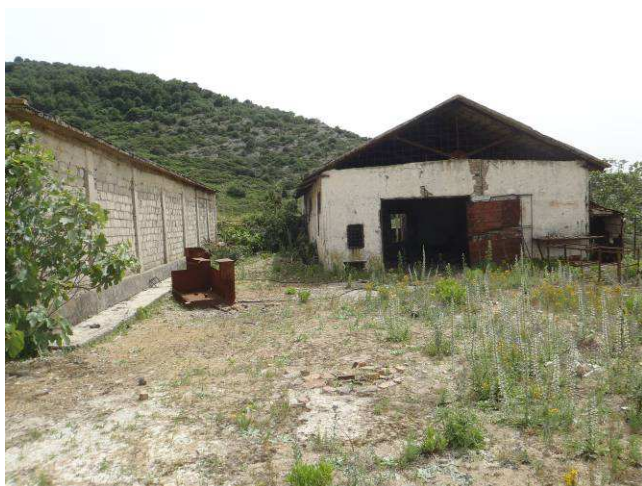
**Location 8:**  
Ground floor bricks construction with concrete roof (partly collapsed).  
Metal : 0.4 ton (large metallic wheels)

**Location 9:**  
Ground floor collapsed masonry construction.  
Metal : 0.5 ton (car wreck)

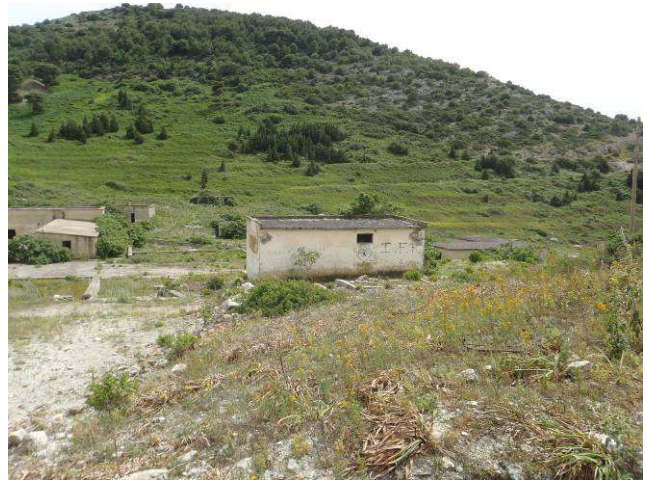
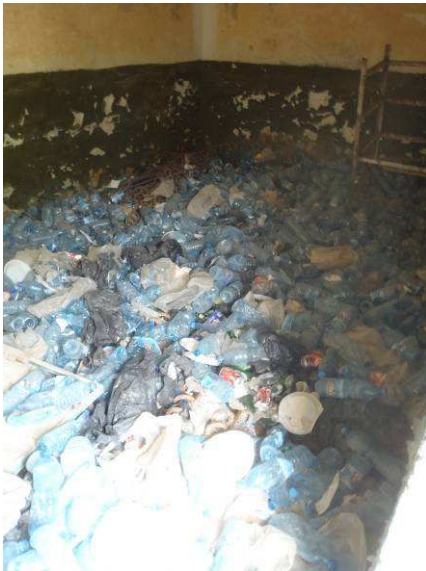
**Location 10:**  
Two ground floor collapsed masonry and bricks constructions.  
Metal : 2 tons  
0.3 ton of non-hazardous industrial waste (wood,...).

**Location 11:**  
Two smalls ground floor masonry and bricks constructions.  
Metal : 0.2 ton

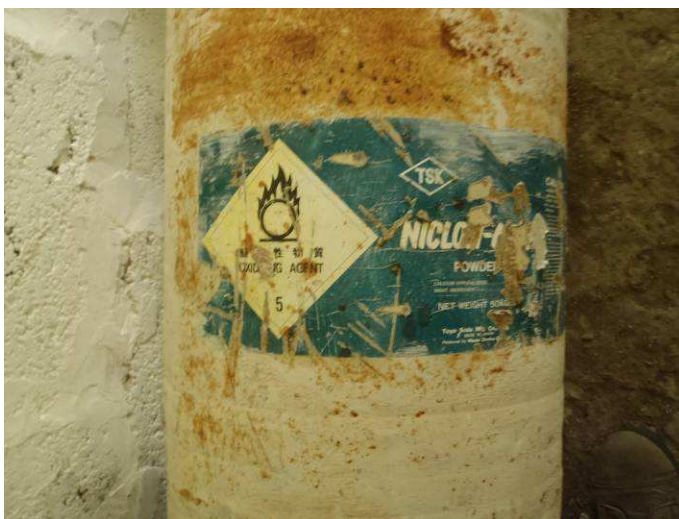
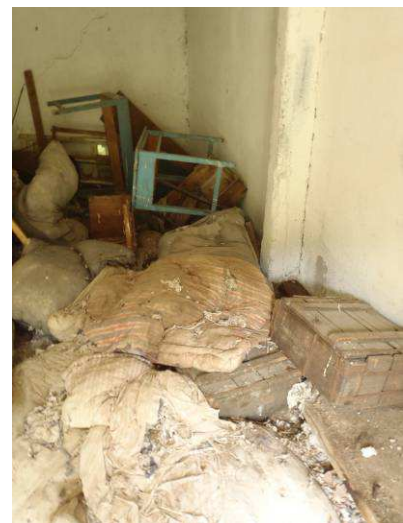
**Location 13:**  
Ground floor bricks construction.  
Metal : 0.5 tons  
Non-hazardous industrial waste : 0.2 ton (wood, mattress,...)  
3 barrel of hazardous wastes (calcium hypochlorite : Oxidant (O)Corrosive (C)Harmful (Xn)Dangerous for the environment (N) - R-phrases :R8, R22, R31, R34, R50)

5 barrels full of undefined substances.

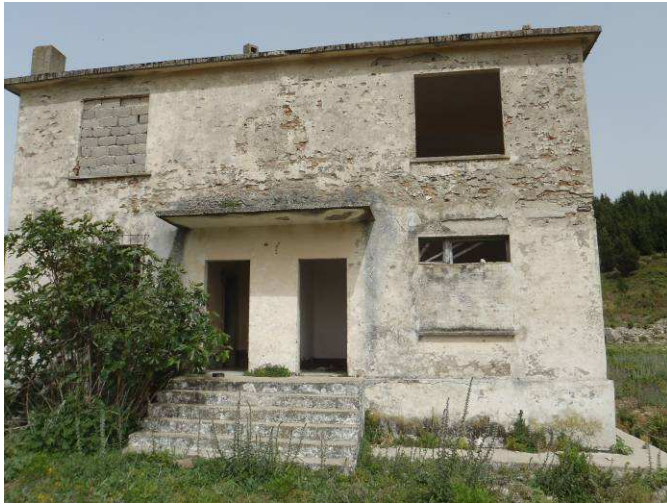
**Location 17:**

Ground floor masonry construction. Roof in asbestos plates collapsed (30 m<sup>2</sup>).

Metal : 0.1 ton (empty barrels)

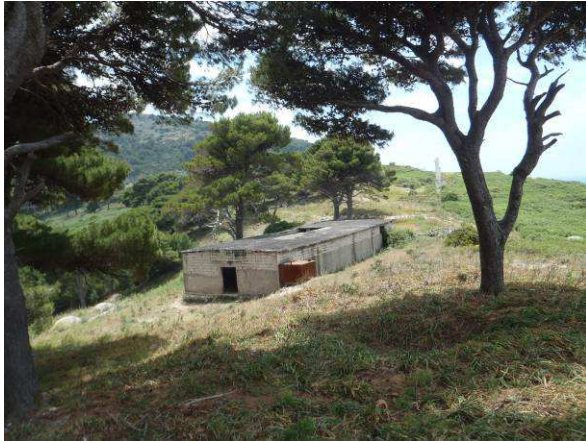
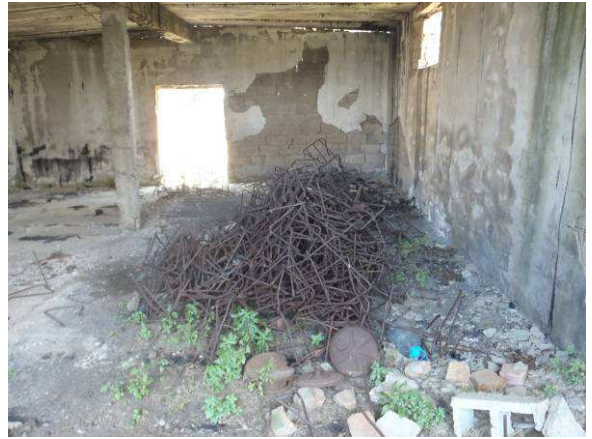
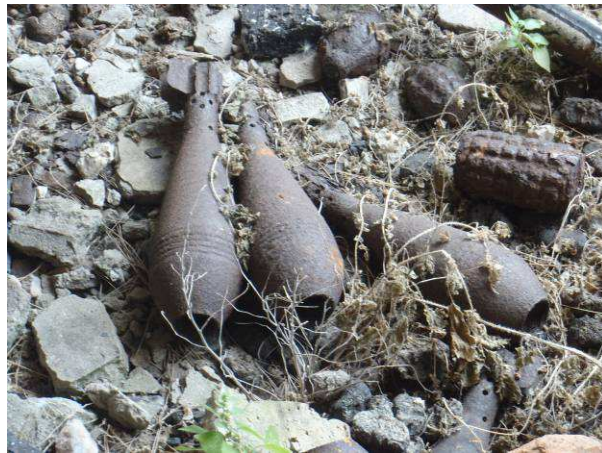
**Location 21:**  
Ground floor impair masonry construction.  
Metal : 0.3 ton

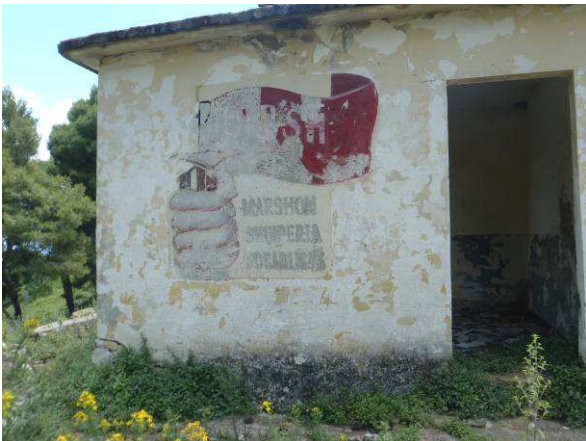
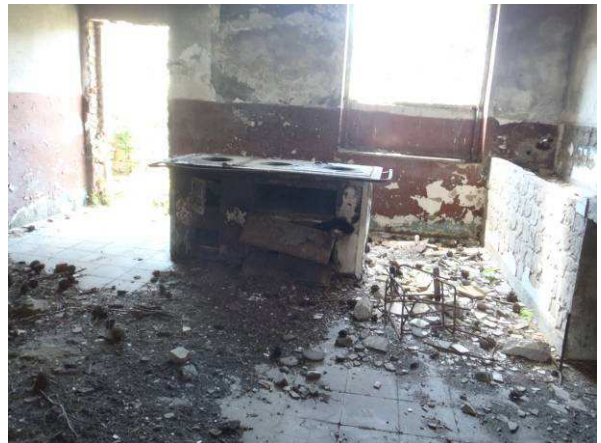
**Location 22:**  
Ground floor bricks construction in middling condition.  
Metal : 0.2 tons

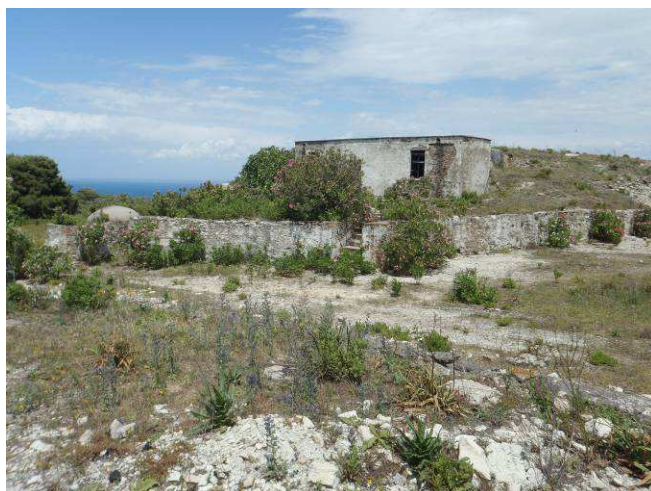
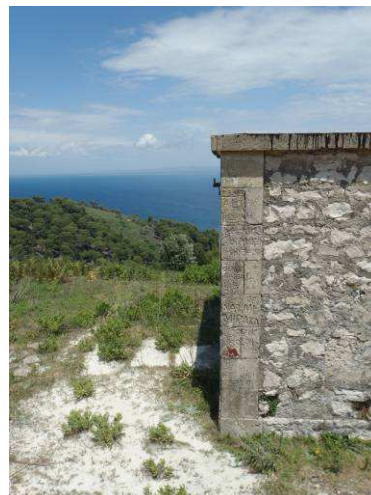
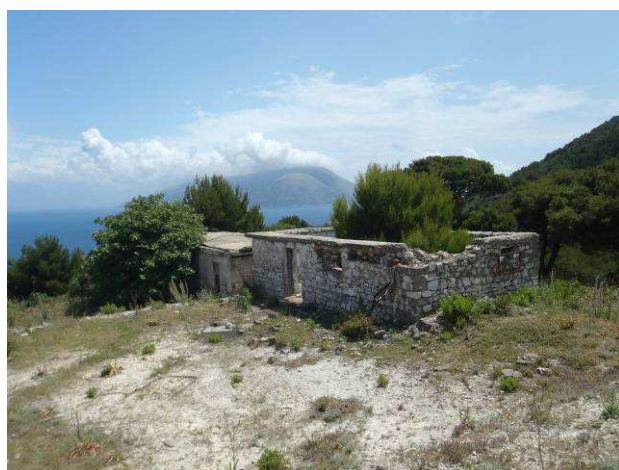
**Location 23:**

Two small ground floor bricks and limestone blocks constructions in quite good condition.

Metal : 0.1 ton

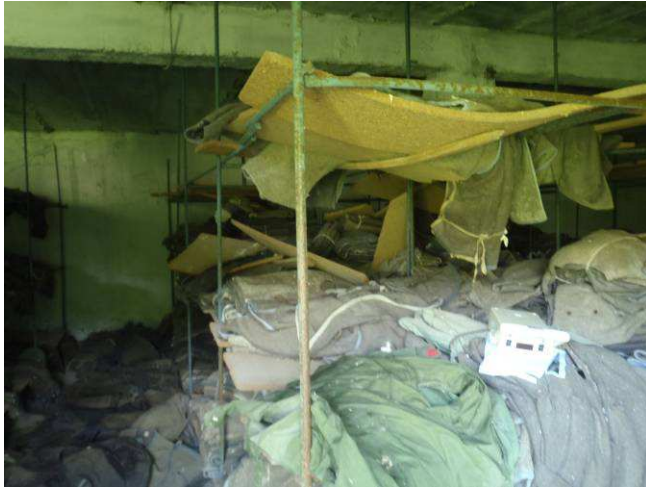
**Location 25:**

Ground floor bricks construction.

Metal : (2 metallic frames outside) 0.2 ton

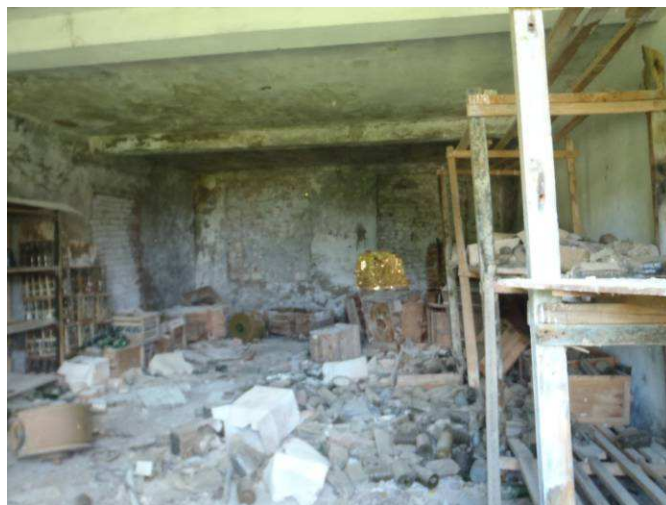
**Location 28:**  
Ground floor bricks construction in average condition.  
Metal : 0.2 ton  
Wood : 0.1 ton

**Location 29:**  
Ground floor bricks construction in average condition.  
Metal : 0.2 ton  
recent grenades (10 boxes).  
Wood : 0.2 ton
