EXPERTISE REPORT

December 2013

# Sazani island (Albania) : pollution and wastes field survey

Jean-Louis Lambeaux (13 Développement)

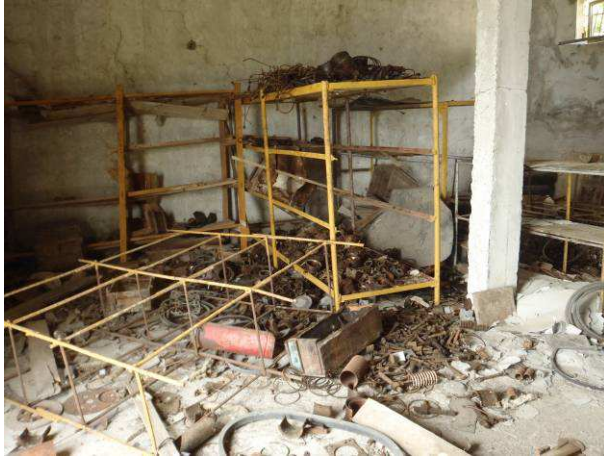
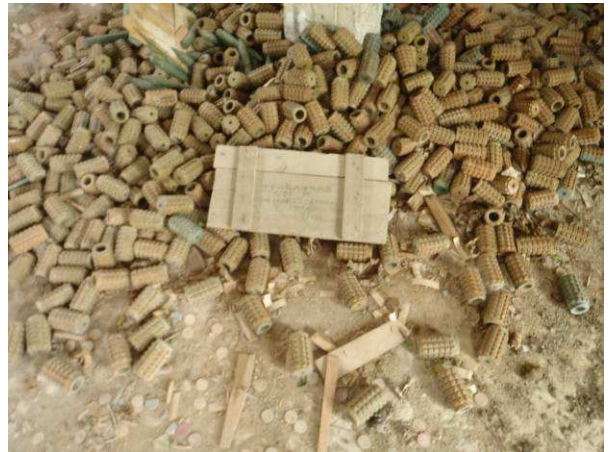
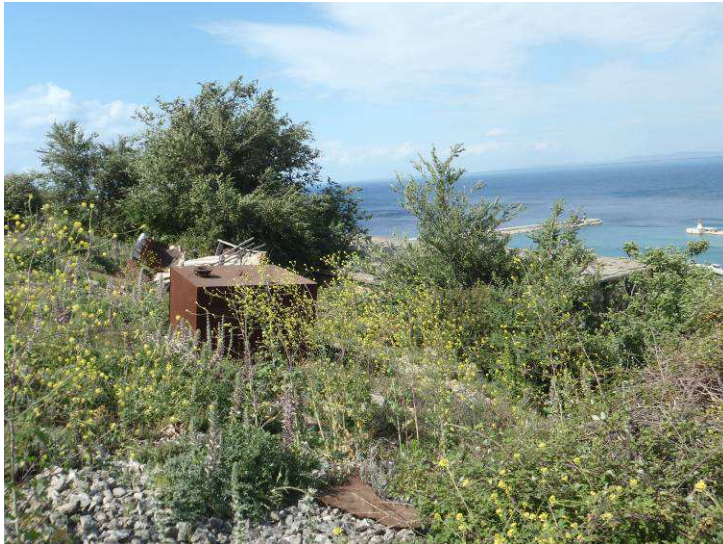
**Location 5:**

Group of four ground-floor masonry and concrete flat roof constructions.  
Metal : 2.5 tons

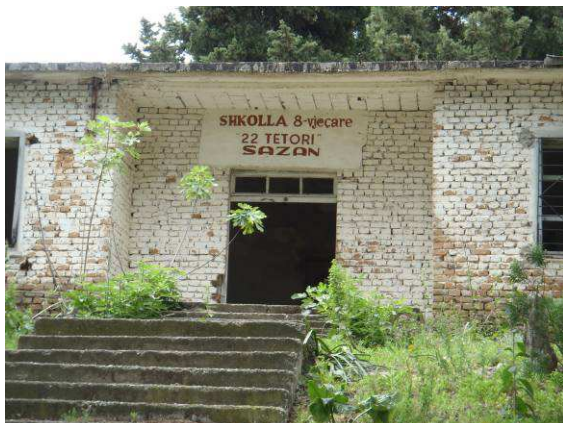
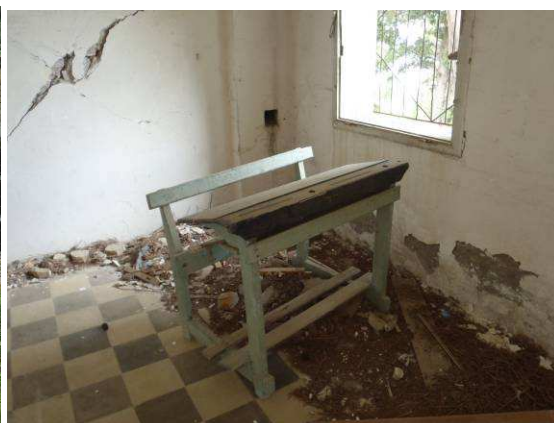
**Location 2:**

Housing : Two-floors masonry construction partly collapsed.  
Metal : 1.5 tons  
Garbage (wood, fabrics, mattress, plastic,...) : 0.2 tons

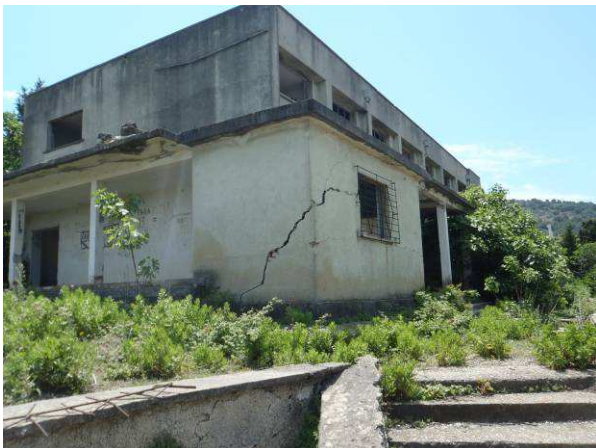
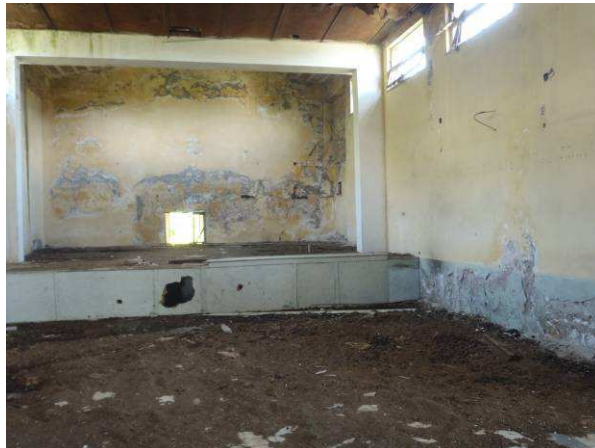
**Location 16:**

Small masonry construction.

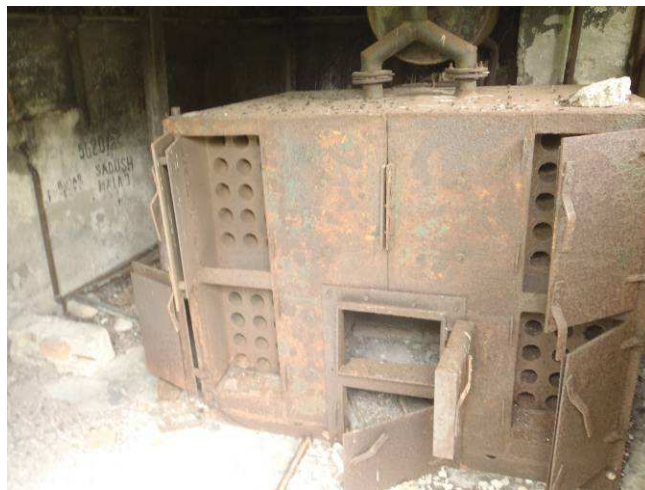
**Location 15:**

Ground floor bricks and concrete construction.

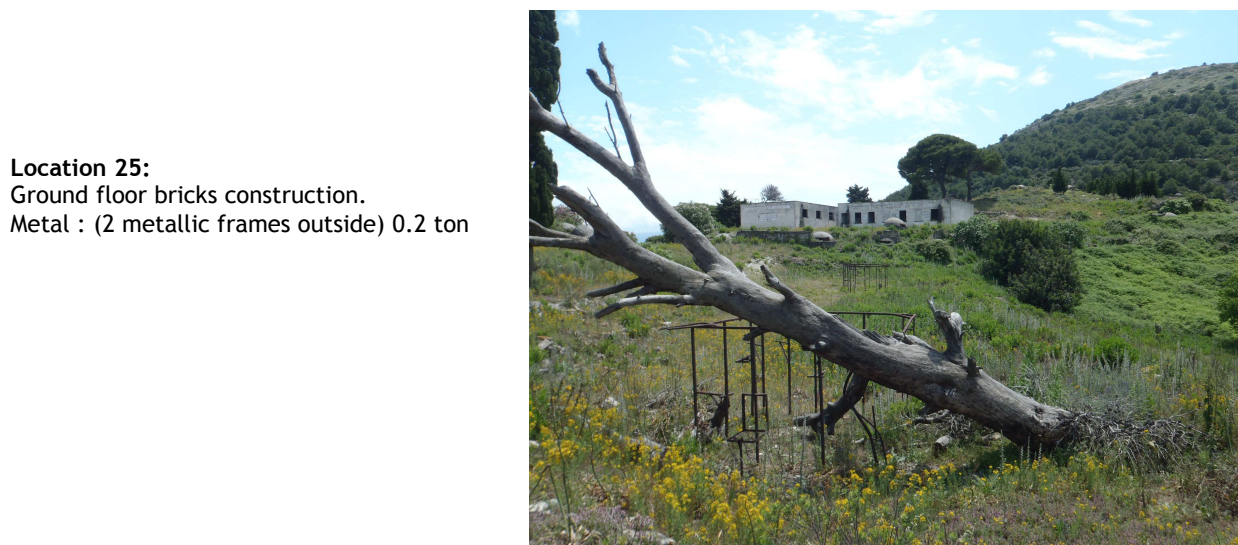
**Location 25:**

Ground floor bricks construction.
